Subject: Vessel Inspection Inventory Report (Utica, Gradall 2)

VESSEL INSPECTION INVENTORY REPORT

UTICA, GRADALL 2

OCTOBER 2022

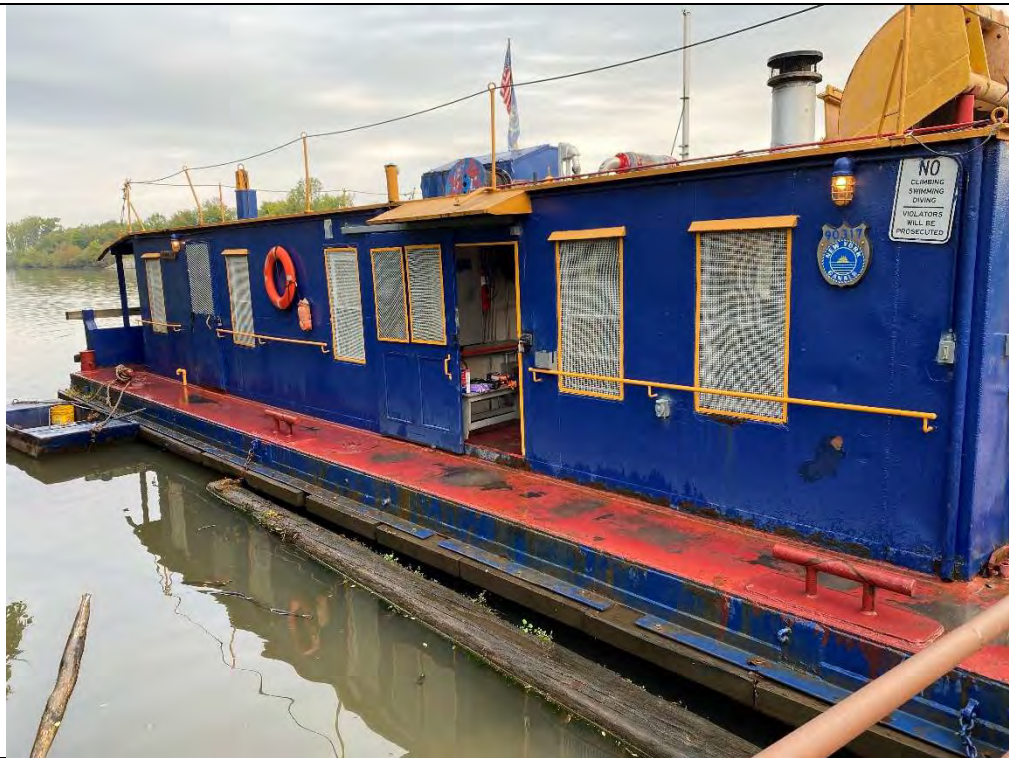
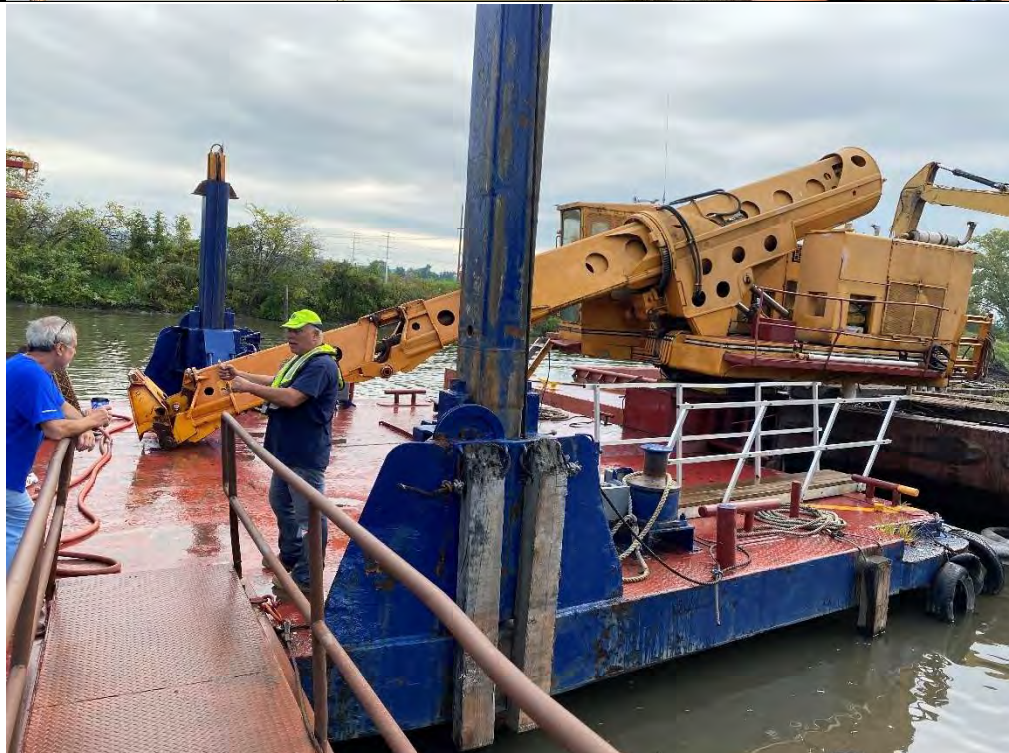
Description: Starboard side

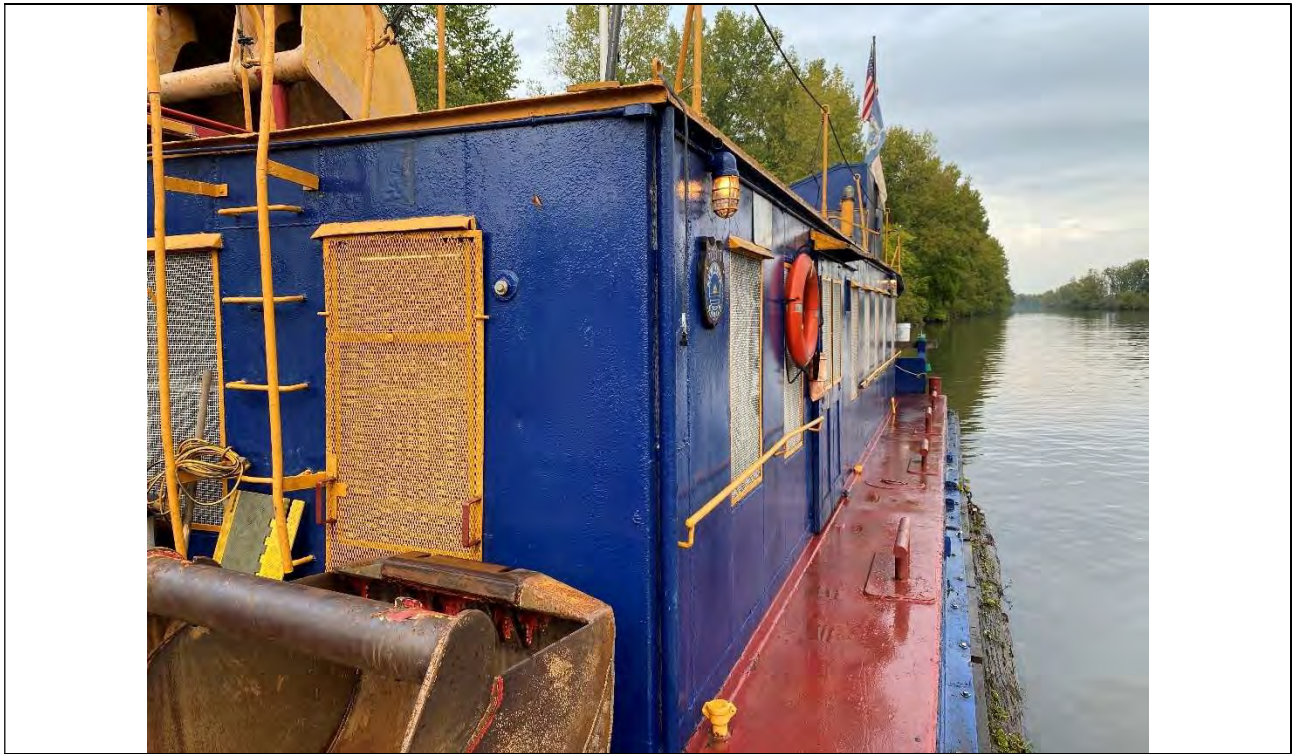
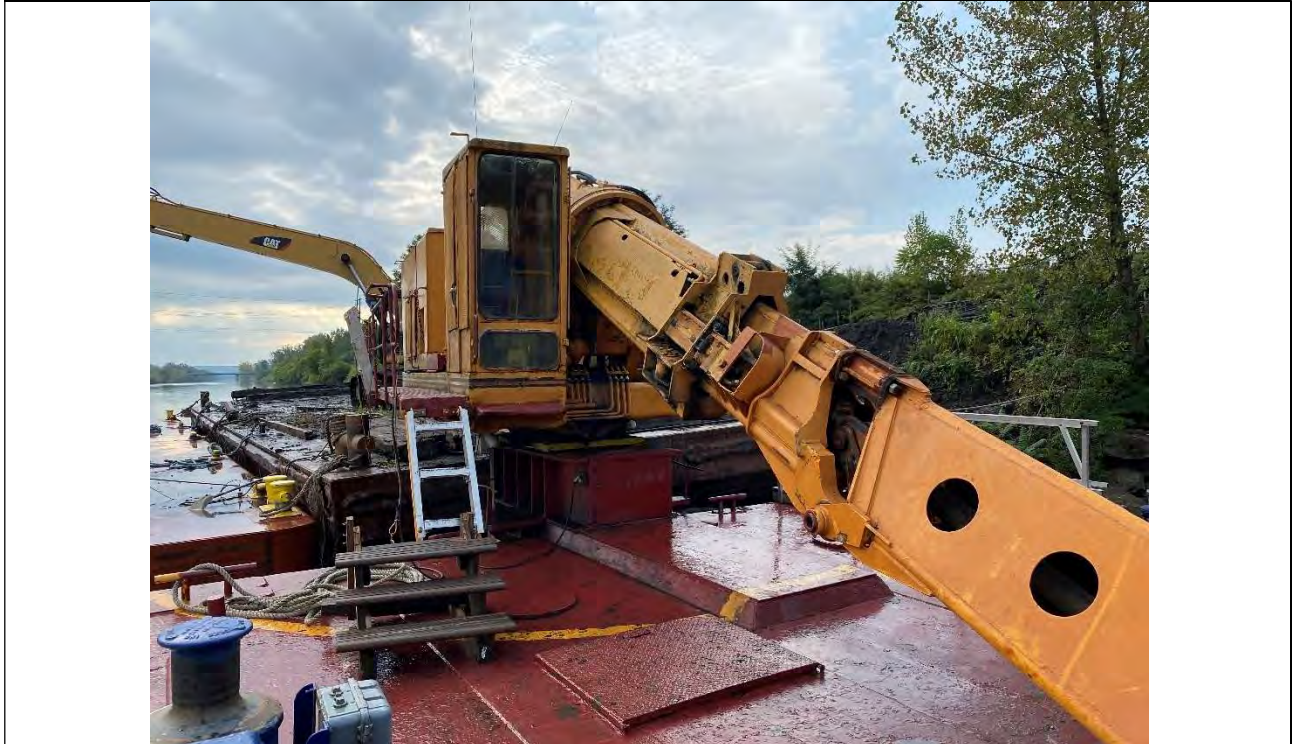
Description: Port side

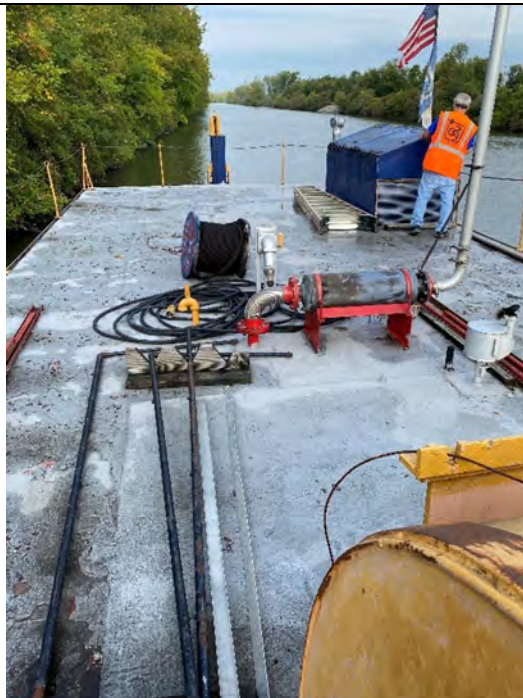
Description: Roof of vessel; blueprint ref. A

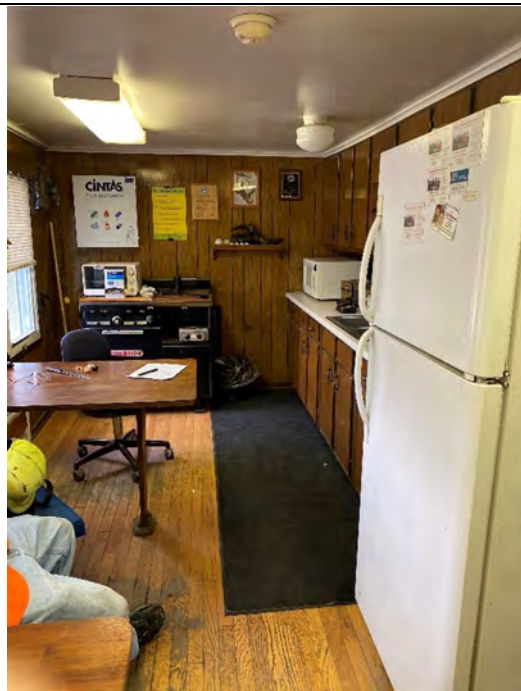
Description: Fridge, south bend oven, toaster, toaster oven, and microwave; blueprint ref. B

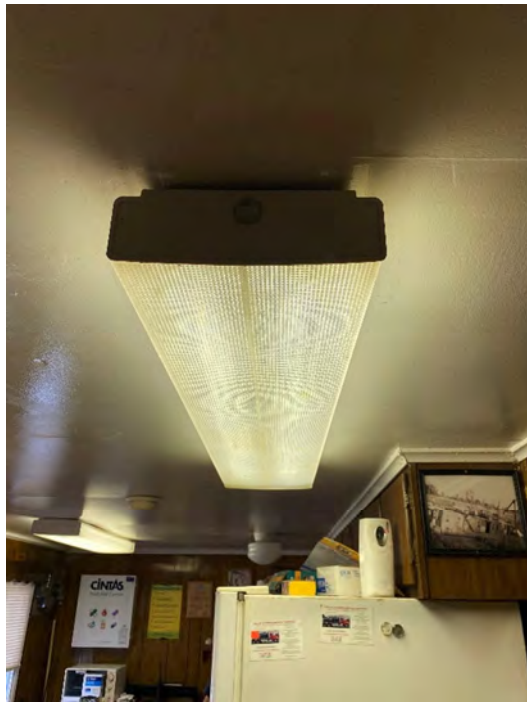
Description: 6 fluorescent tubes and ballasts kitchen; blueprint ref. C

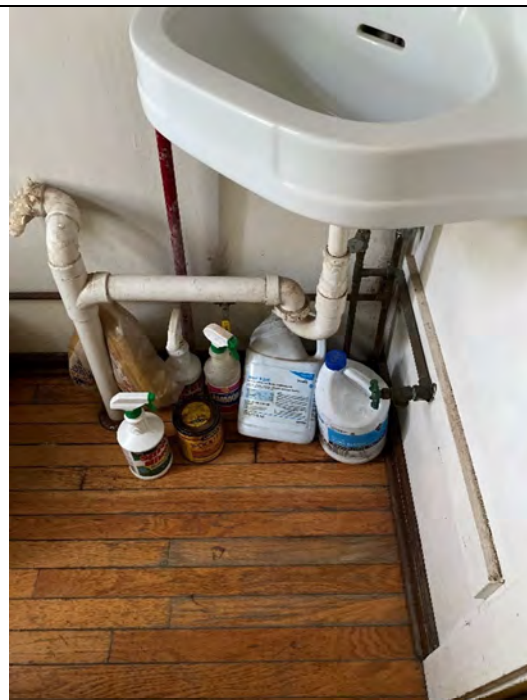
Description: Bathroom bottles; blueprint ref. D

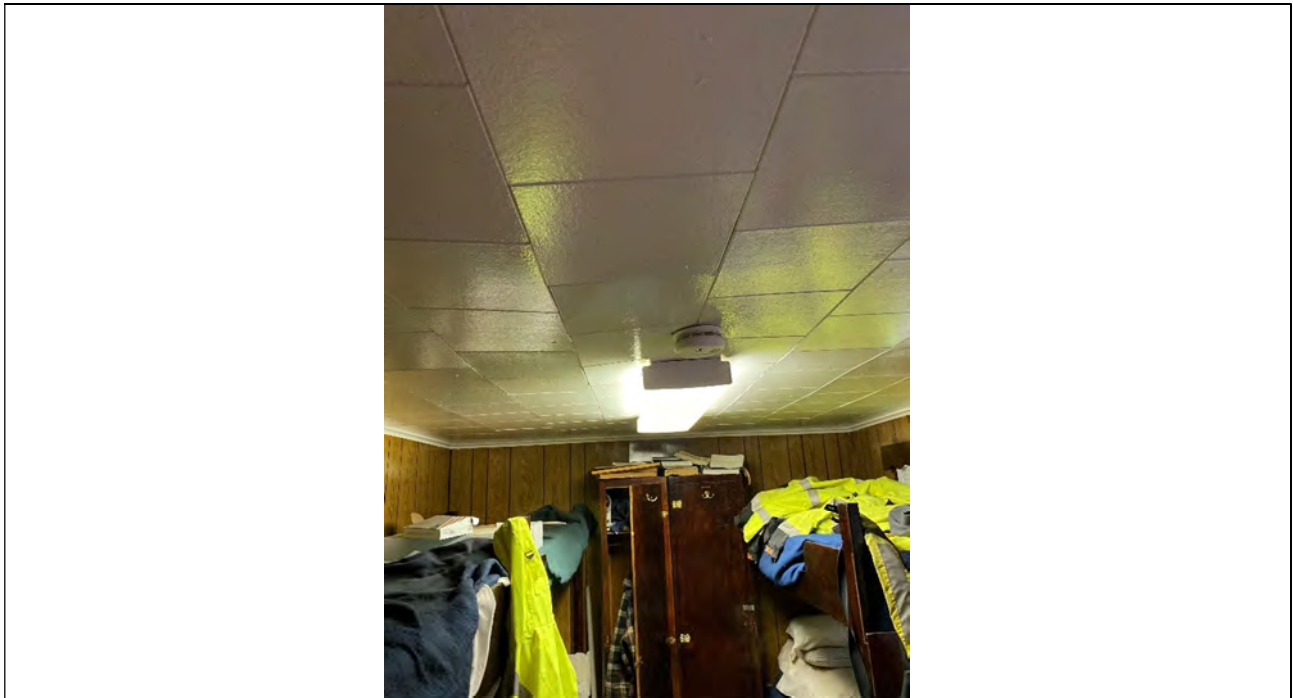
Description: 2 fluorescent tubes and ballasts in bunk room; blueprint ref. F

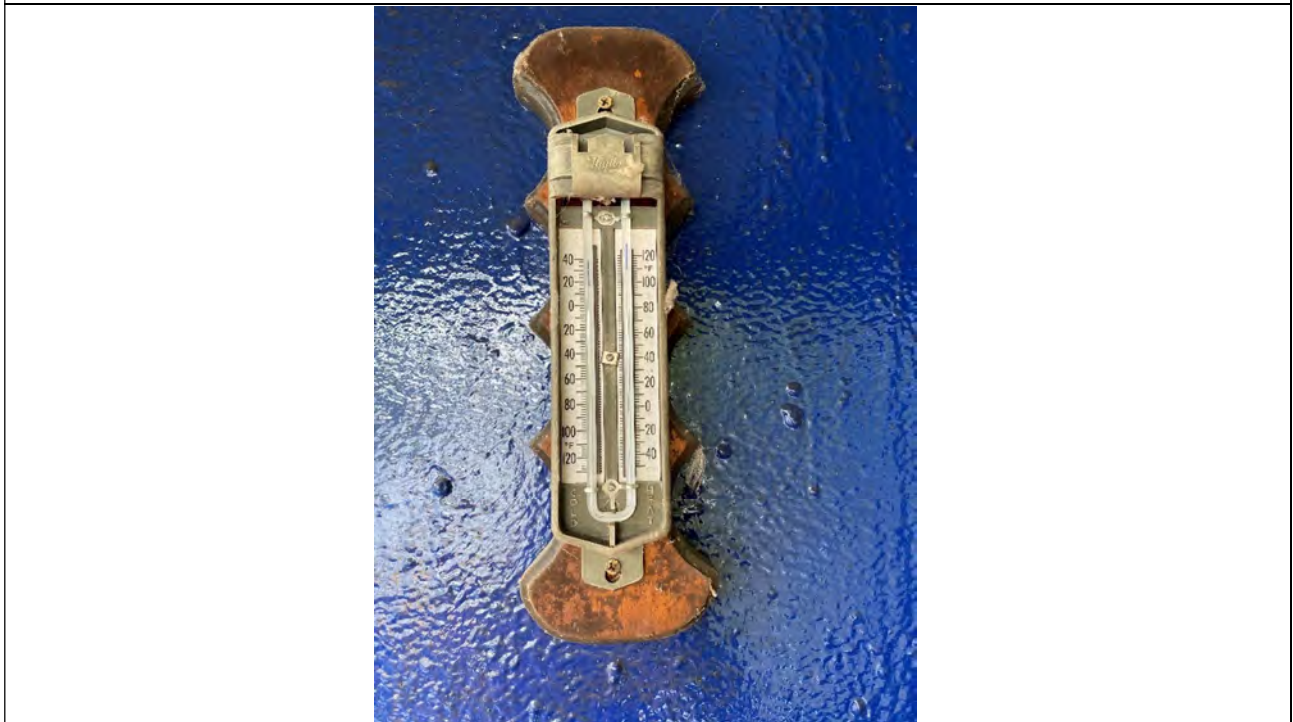
Description: Stern thermometer; blueprint ref. G

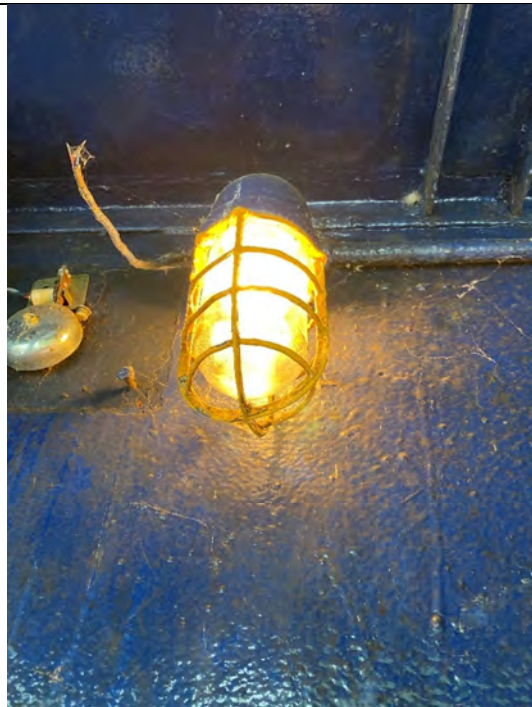
Description: 6 incandescent lights around vessel exterior; blueprint ref. H

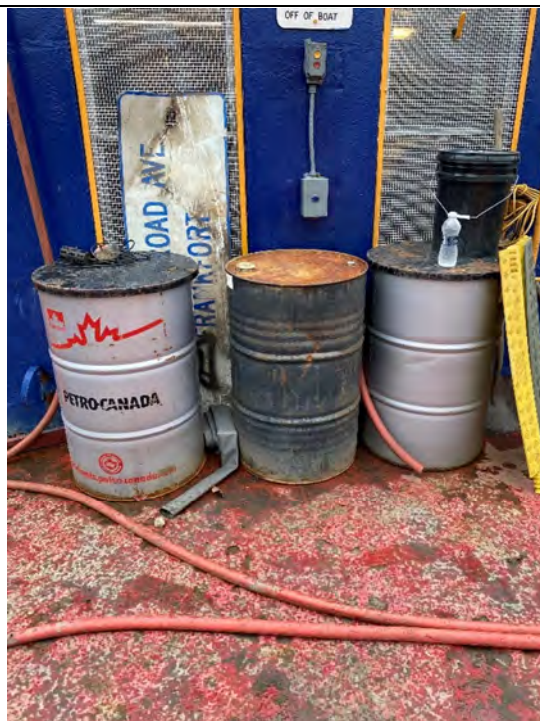
Description: 3 waste oil tanks with ~20 gallons waste oil total: blueprint ref. I. Note push button control box behind drums

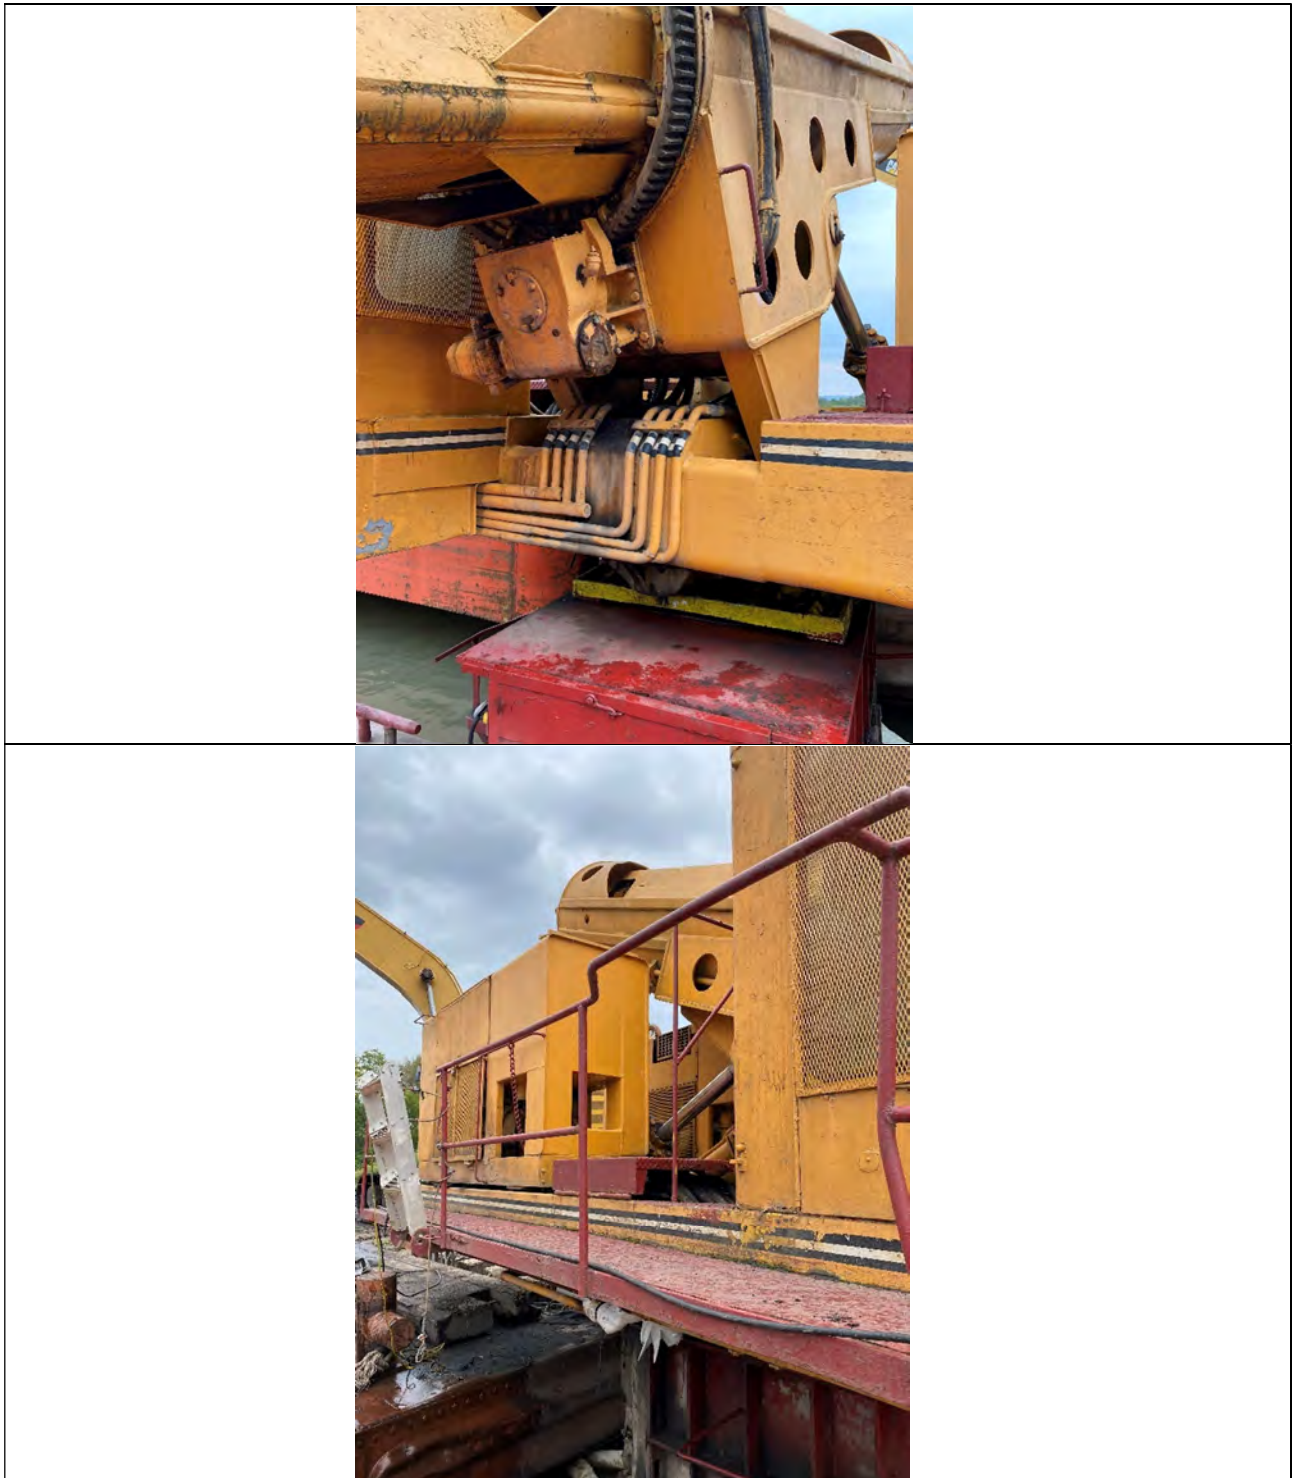
Description: Gradall assembly; blueprint ref. J

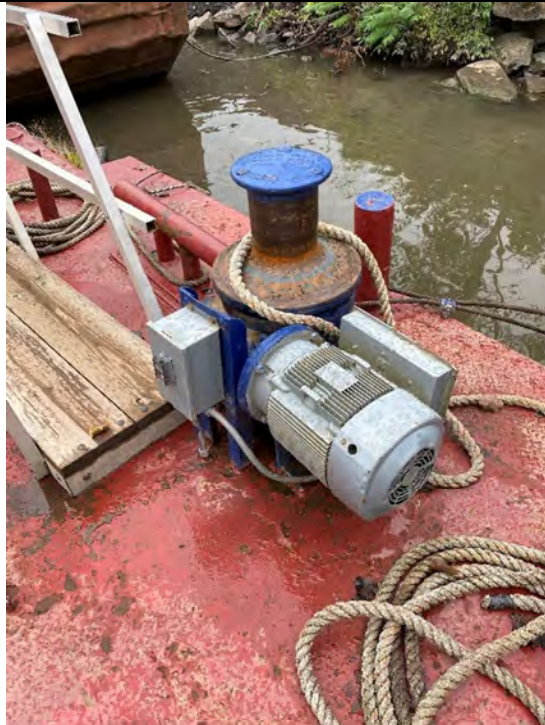
Description: Bit electric motor port and starboard bow; blueprint ref. K

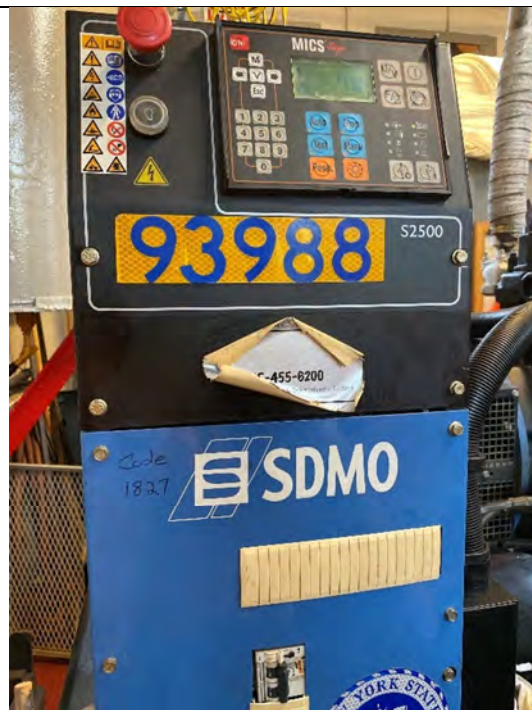
Description: SDMO generator and control panel; blueprint ref. L

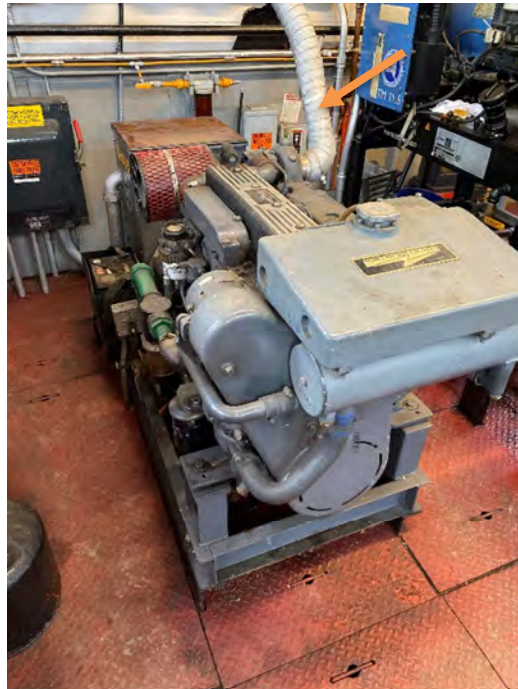
Newage generator thermal system insulation (PCB-1) and grease below the newage generator (PCB-2) were identified as suspect for PCB contamination on Gradall 2. A sample was collected from each location, identified by reference letters M and Z, respectively in **Attachment C**. Sample IDs, descriptions, locations, and PCB analysis results are shown in **Table 5**. A copy of the results and chain of custody record are included in **Attachment D**.

Sample No.	Description	Sample Location	PCB Analysis Results
PCB-1	Newage generator thermal system insulation	Engine room	None detected
PCB-2	Grease below newage generator	Engine room	None detected

Description: Newage generator; TSI sampled (PCB-1 and 3,A-B); blueprint ref. M

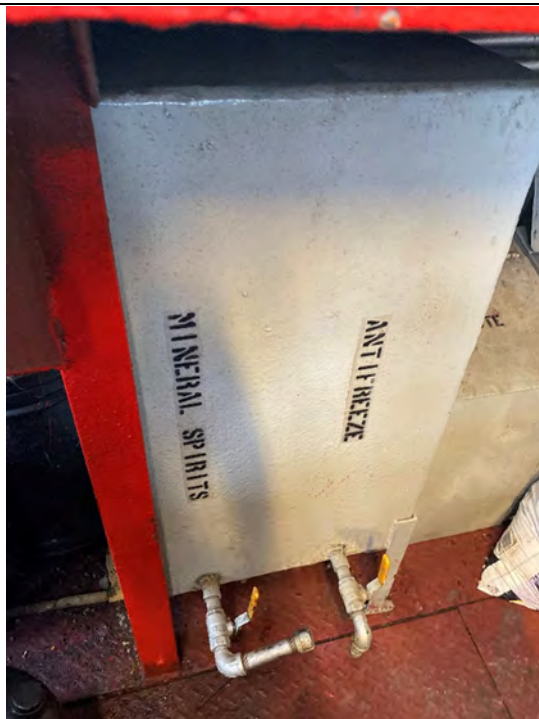
Description: Mineral oil and anti-freeze, ~5 gallons each; blueprint ref. N

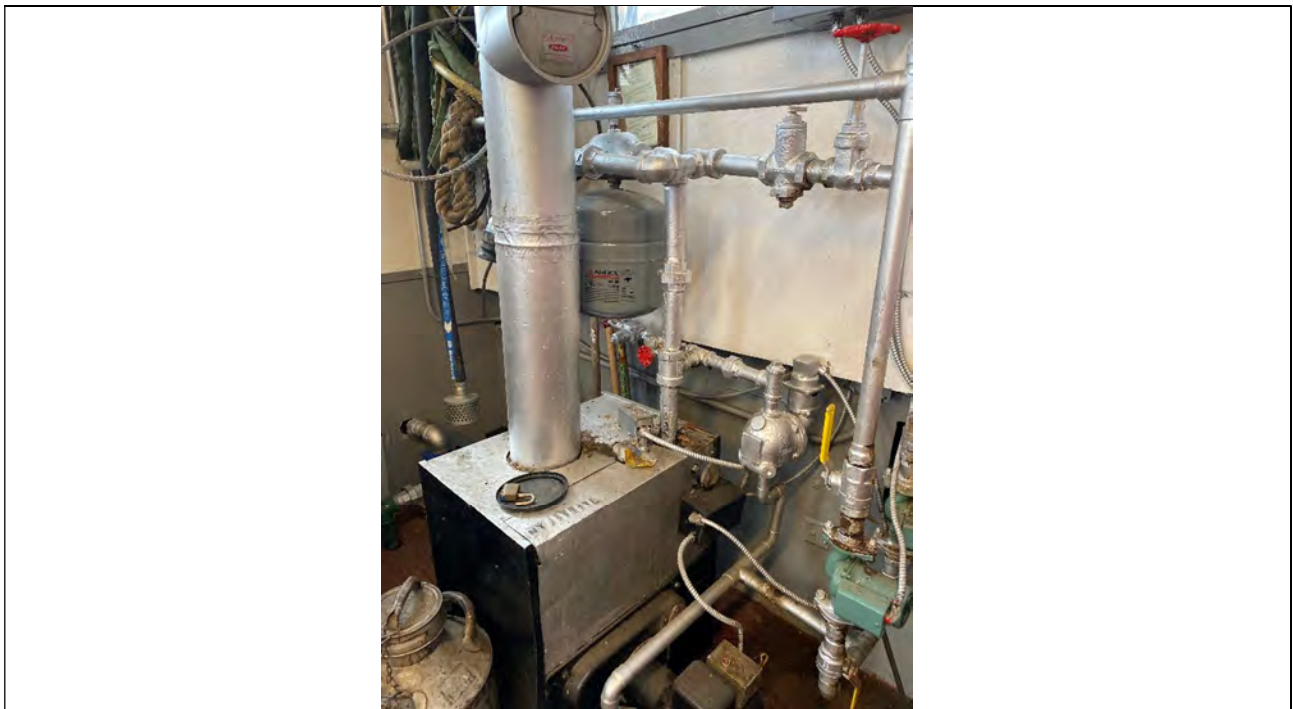
Description: Oil furnace; blueprint ref. O

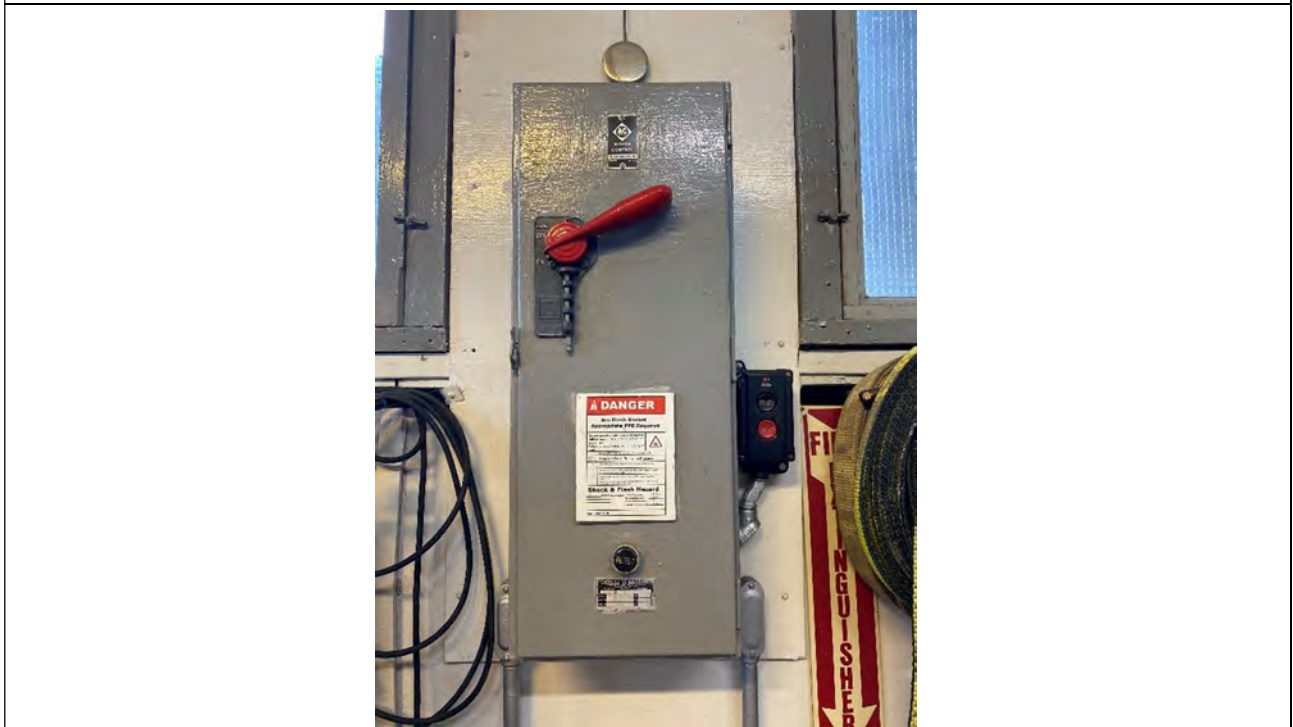
Description: Motor control box; blueprint ref. P

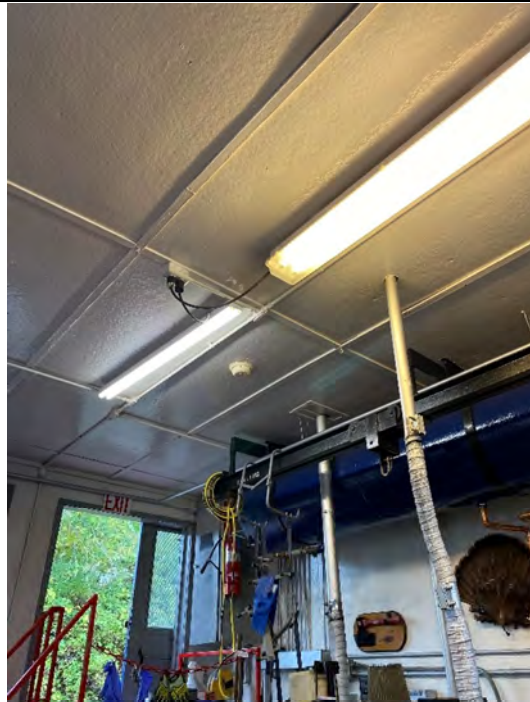
Description: 6 fluorescent lights and ballasts engine room, blue tank at top of photo is potable water; blueprint ref. Q

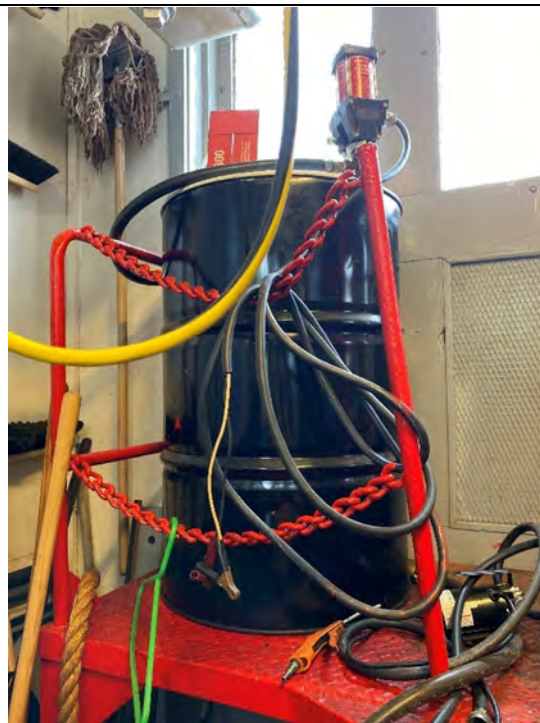
Description: Oil drum with ~20 gallons oil; blueprint ref. R

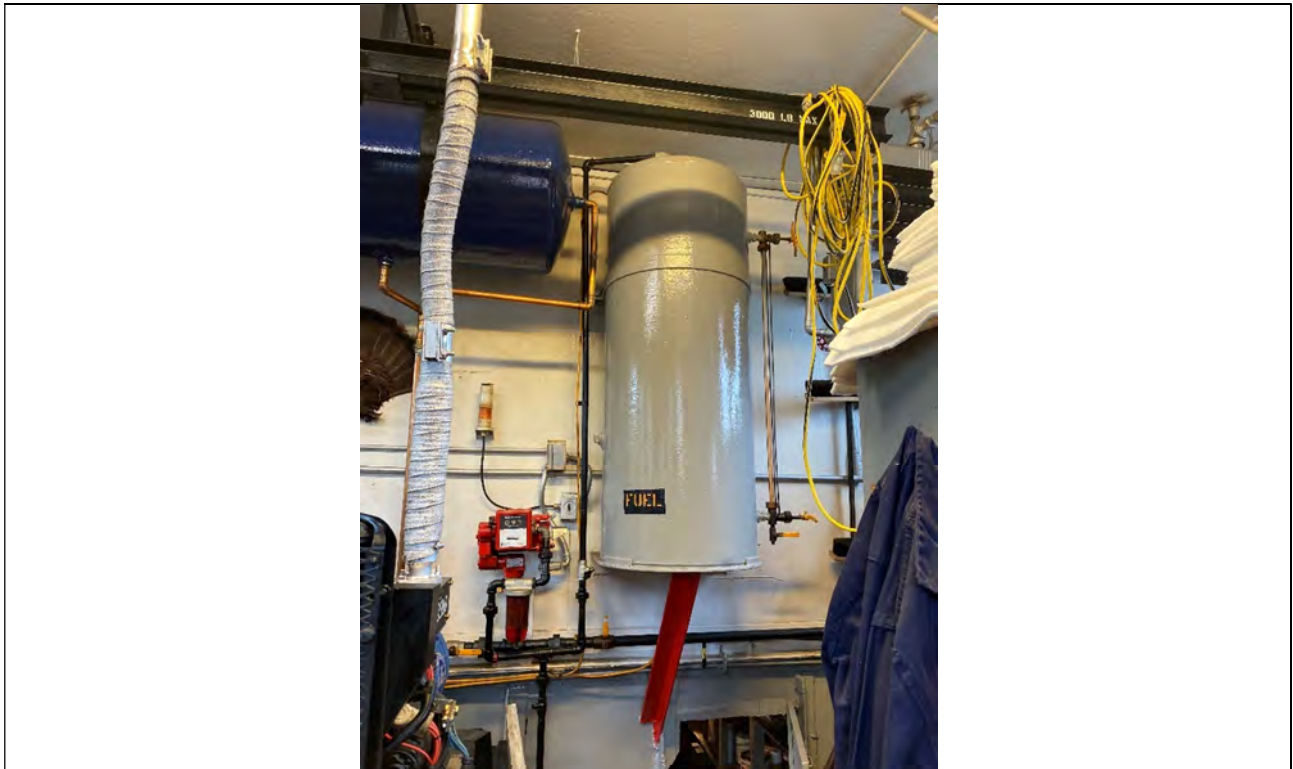
Description: Fuel tank with ~100 gallons diesel fuel; blueprint ref. S
